Chimney Inspection Report

Client Name: Sample Report
Street Address: 123 Main St
City, State, Zip: Anytown NY 14564
Inspector: Justin Kesel
Weather: Clear, Cold
Chimney Type: Brick and Block
[Kitchen Liner Video](#)
[Livingroom Liner Video](#)

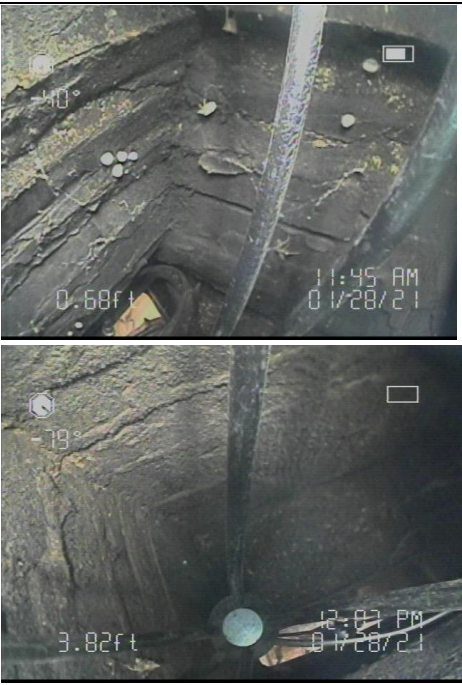
<p>The inspector noted hearths, hearth extensions or chambers that had joint separation, damage or deterioration.</p>	<p>Yes</p>

<p>Fire place(top) and Kitchen fire box(below) have bare brick and should be parged with an approved material to facilitate proper drafting of combustion products.</p>
<i>Single-Wall Metal Chimneys (Initial Inspection)</i>		
<p>The inspector noted single-wall metal chimneys in one- or two-family dwellings. Single-wall metal chimneys should not be used in one- and two-family dwellings.</p>	<p>Not Applicable</p>	
<p>The inspector noted wall protectors (heat shields) with less than 1-inch air gaps.</p>	<p>Not Applicable</p>	
<p>The inspector noted an exposed interior single-wall metal chimney that was not continuously enclosed where it extended through closets, storage areas, or habitable spaces, or where the surface of the chimney could come into contact with combustible materials or people.</p>	<p>Not Applicable</p>

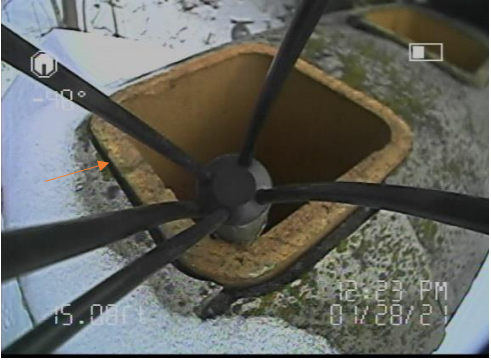
<i>Chimney Outlet</i>		
The inspector noted a missing ventilating thimble where a chimney passed through a combustible roof.	Not Applicable	
The inspector noted a chimney that terminated less than 3 feet above the highest point where it passed through a roof surface	No	
The inspector noted a chimney that terminated less than 2 feet above a portion of a building (ridge, wall or parapet) within 10 feet.	No	
The inspector noted a chimney that terminated less than 3 feet from an adjacent building or building opening.	No	
The inspector noted a chimney that terminated less than 10 feet above grade or a walkway.	No	
The inspector noted the flue (s) were missing rain caps and spark screens	Yes

<p>Recommend installing a spark screen and rain cap. A cap the will help prevent water from entering the flue. The screen will extinguish small sparks and prevent birds from making a nest.</p>
The inspector noted a chimney outlet that jeopardized people, overheated combustible structures, or that might cause flue gases to enter nearby building openings.	No

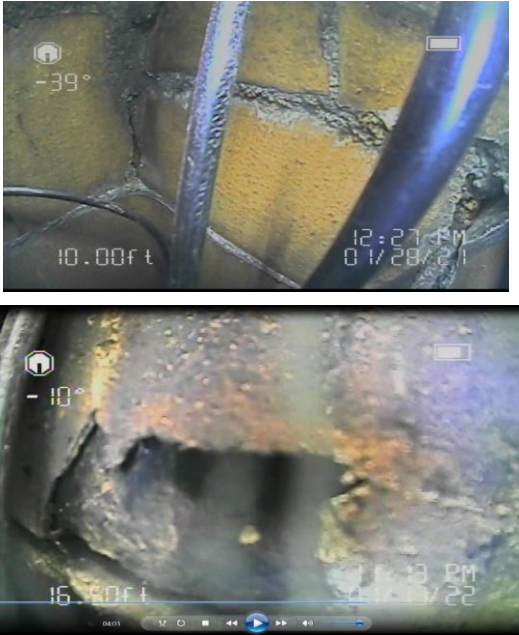
<p>The inspector noted a liner that was visibly softened, cracked, deteriorated or damaged.</p>	<p>Yes</p>

<p>Smoke chambers are un-parged and damage was noted to the flues. These area should be repaired or re-lined by qualified chimney professional prior to n next use.</p>
<p>The inspector noted a liner that had excessive accumulation of creosote, soot, or other combustible material.</p>	<p>No</p>	
<p>The inspector noted a flue that had two or more openings at the same level.</p>	<p>No</p>	
<p>The inspector noted an appliance venting into the space around and between liners. The remaining space surrounding a chimney liner should not be used as a vent.</p>	<p>No</p>	
<i>Flue Size</i>		
<p>The inspector noted that the size of the flue was too small relative to the size of the fireplace opening. This relationship is the most important factor in achieving sufficient draft. A flue that is too small relative to the fireplace opening will be unable to lift and remove hazardous flue gases to the outside.</p>	<p>No</p>
